Traditional Javanese Wooden Houses (Joglo) Damaged By May 2006 Yogyakarta Earthquake, Indonesia

Prihatmaji, Yulianto P.; Kitamori, Akihisa; Komatsu, Kohei

An Investigation of Traditional Javanese Wooden Houses ‘Joglo’ Damaged during the May 2006 Yogyakarta Earthquake, Indonesia.

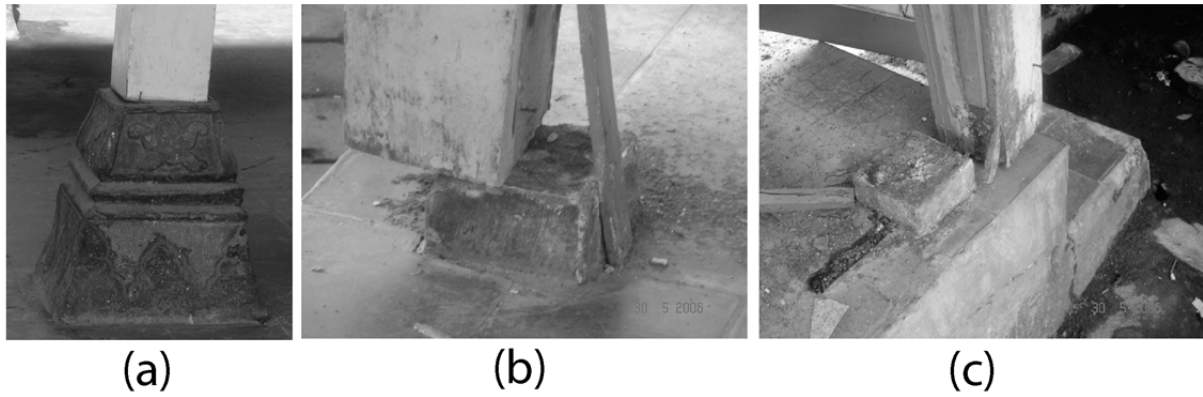
In our research we suggest a number of facts. Tenon of column's end works in securing the position of the columns on the foundation. It makes the structural system able to resist against seismic lateral forces even if columns are inclined (Figure 7a). The fatal damage of the joint between column and foundation occurred when some columns lacked the original tenons (Prihatmaji et al, 2011). This is observed more commonly on side structures rather than core structures (Figure 7b). These columns then easily slipped over the foundation causing total collapse of the structure (Figure 7c). In addition, the joint of column tenon and stone base is seriously damaged when the column's leg has decayed (JHS, 2007; Prihatmaji et al., 2010a). Due to the damage of the column's tenon, the joint failure also represents a critical criterion in terms of building stabilization after a seismic attack.

Figure 7. (a) The declined column, (b) Decaying of the column tenon, (c) The column stand on stone base without tenon.

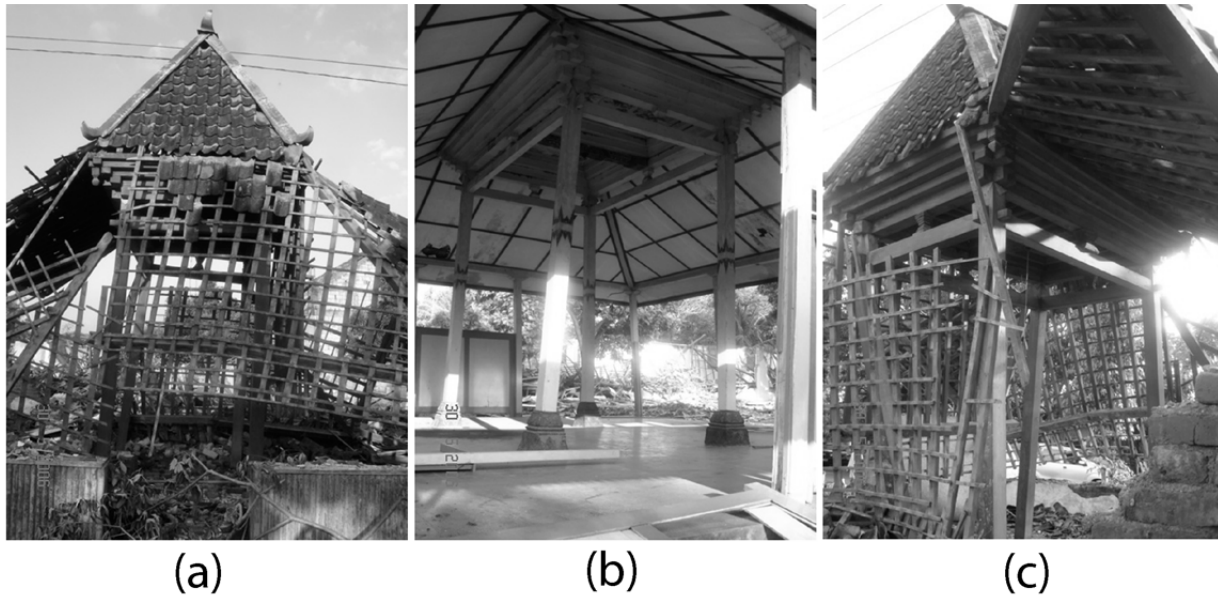
Figure 8a, b and c. State of Joglo's core structure after an earthquake.

Figure 8a-c, shows four columns that are severely inclined but still standing and securing human life. Hence, the role of joints is very important and significant. The most crucial damage between column and beam is observed at joints at the lower and upper beam. The joint of the long beam with the column gets damaged due to shear force and bending moment inside the mortise (Prihatmaji et al., 2011; Prihatmaji et al., 2010b). Furthermore, mortise of columns, into which a number of beams are inserted, may cause a fatal damage on the core structure.

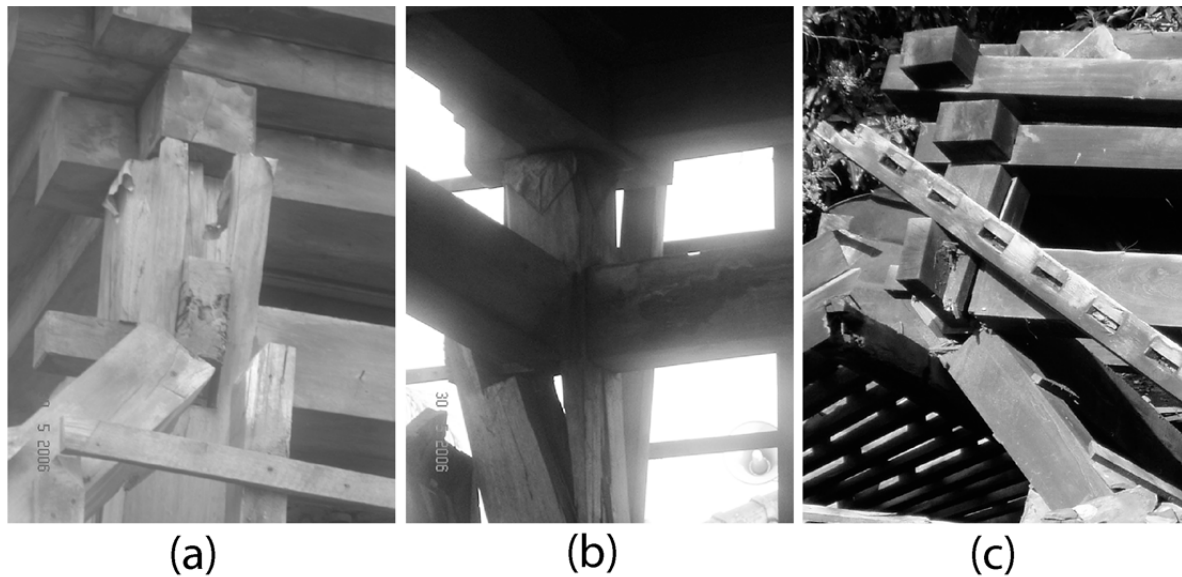
Figure 9a shows that the lower beam transmits lateral forces to the column, causing shear failure between lower and upper beam, resulting in the damage of both the column and the beam. When the strength of the column is weaker than that of the joints, (e.g. due to dimension loss by decay or carving), the column failed to bend, without the beams being damaged (Figure 9b). This may result in a total collapse of the structure, as seen in Figure 9c.

Figure 9. (a) Collapsed column-to-beam joint, (b) Broken joint, (c) Collapse of the core structure (@ JHS, 2006).

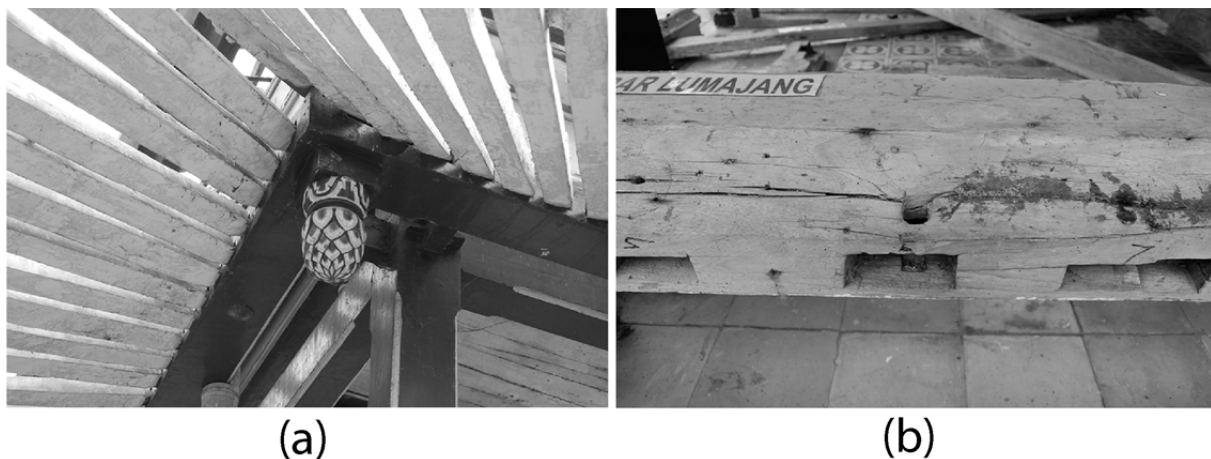
A clear indication of the roof construction's failure begins with the column slipping from the stone base. Due to differences of in-plane stiffness between outer and core structure, only outer structure is largely shaken when earthquake force is applied. This is because both in-plane stiffness and vertical stiffness of core structure are higher than that of outer structure. The rafters of the roof of the core and the outer structure have mortise inserted at the outermost band of rectangular beams. Figures 10a-b show the outermost band of rectangular beams in detail. The shape of the mortise is highly complicated (Figure 4b); basically consisting on a parallelogram with different angles. The rectangular shaped mortises are only at the middle of the beam, this is common for rafters placed around the corner of the roof flanking the hip rafters. The slip of column or any large deformation of the outer structure causes the rafter to be pulled out from the main beam. Hence, the outer structure becomes unstable and collapses.

Figure 10. (a) The outermost band of rectangular beams, (b) mortises beam, where a series of rafter will be inserted.

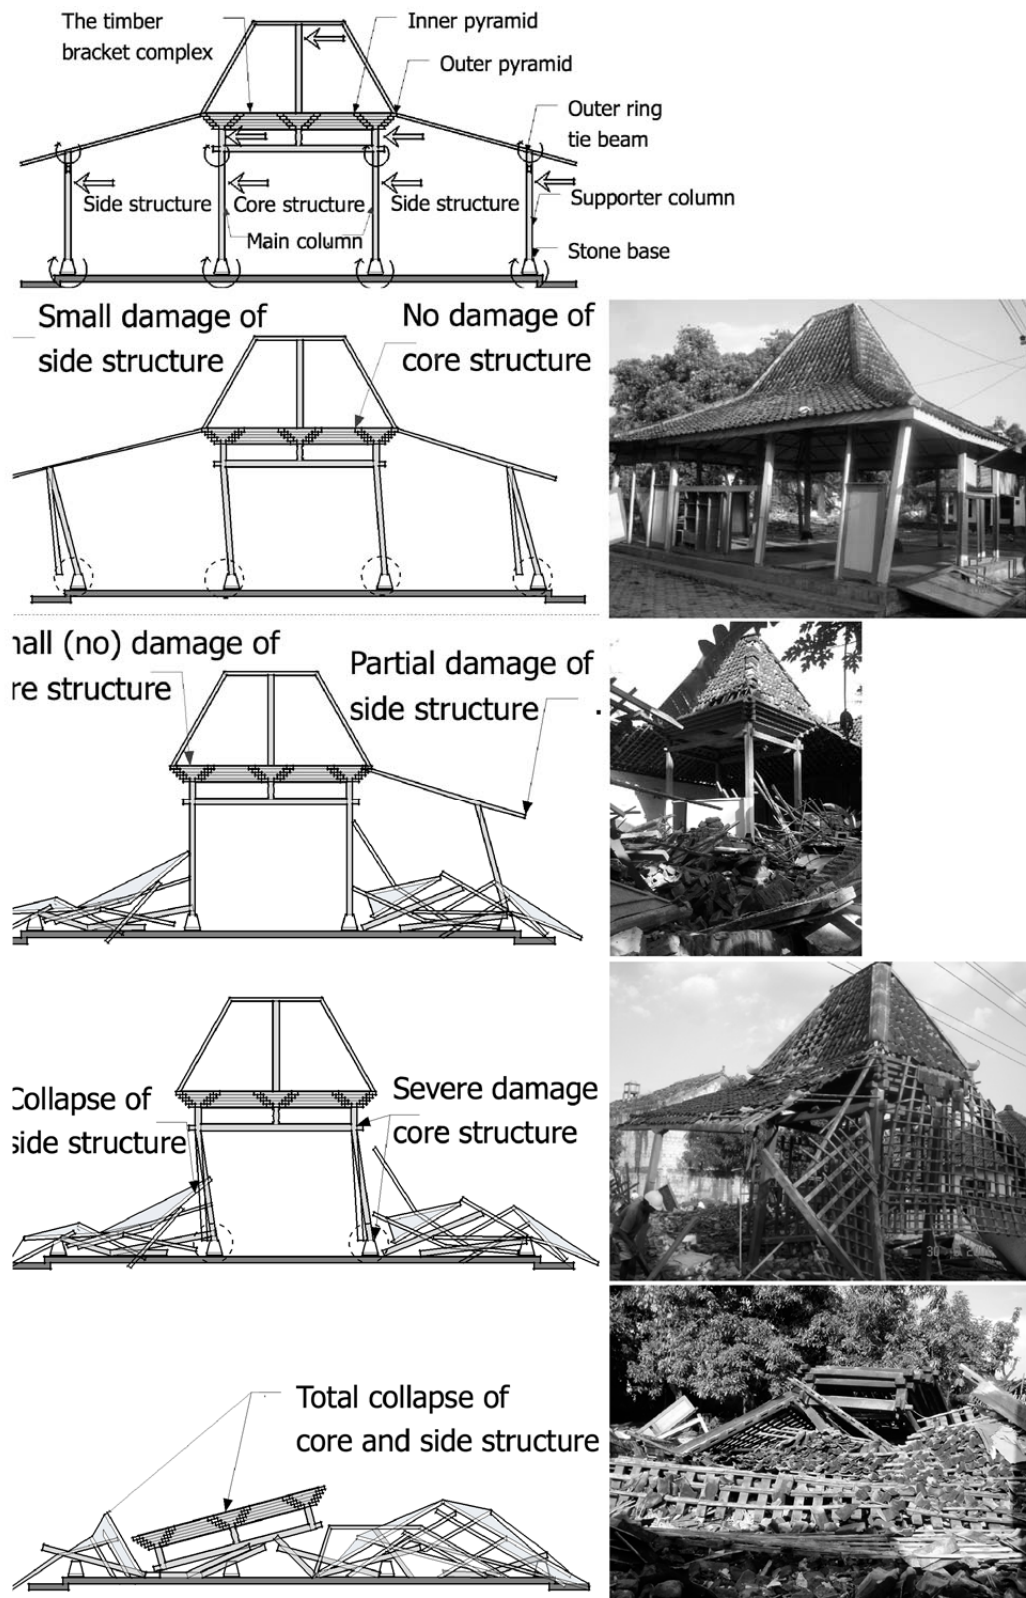
Figures 11a-d show different levels of damage in Joglo-type structures. We categorized them into 4 levels according to the gravity for the structural security and in order of appearance. Firstly, part of the side structure is selectively damaged while the core structure is still standing. This is due to the

difference of strength performance, as shown in Figure 11a. Secondly, the side structure is partially collapsed or damaged while the core structure is slightly or not damaged (Figure 11b).

Figure 11. Levels of damage of the Joglo building (a) First level of damage, (b) Second level of damage (Figure 10b in right courtesy by Wulandari, 2006), (c) Third level of damage, (d) Fourth level of damage (Figure Figure 10a, b and d in left modified from Prihatmaji, 2010b and Ikaputra, 2011. Figure 10d in right modified from JHS, 2007).

Figure 11c shows the third level of damage, which is identified by the collapse of the side structure, with the core structure remaining standing. At this stage, the core structure's columns are inclined but safe. This indicates the importance of the strength performance of the core structure for the security of the residents. At the fourth level of damage, the entire structure falls-down due to the collapse of core and side structure (Figure 11d).

The specific feature of the first level of damage involves broken mortise of columns, and slip between columns and stone foundations at the side structure, decline of column of side structure, and damage of outer ring joint. In the secondary level, joints between outer ring's beam and column are deformed or broken, and joints between inner ring beam at core structure and rafters broke, due to the rafter end connection being pulled out. In the third level, severe damages on the core structure are observed besides second level of damage. Severe damage on core structure is due to the main column's declining and breaking of the joint at lower beam of core structure. The main structures are totally collapsed including roof structures in the fourth level.

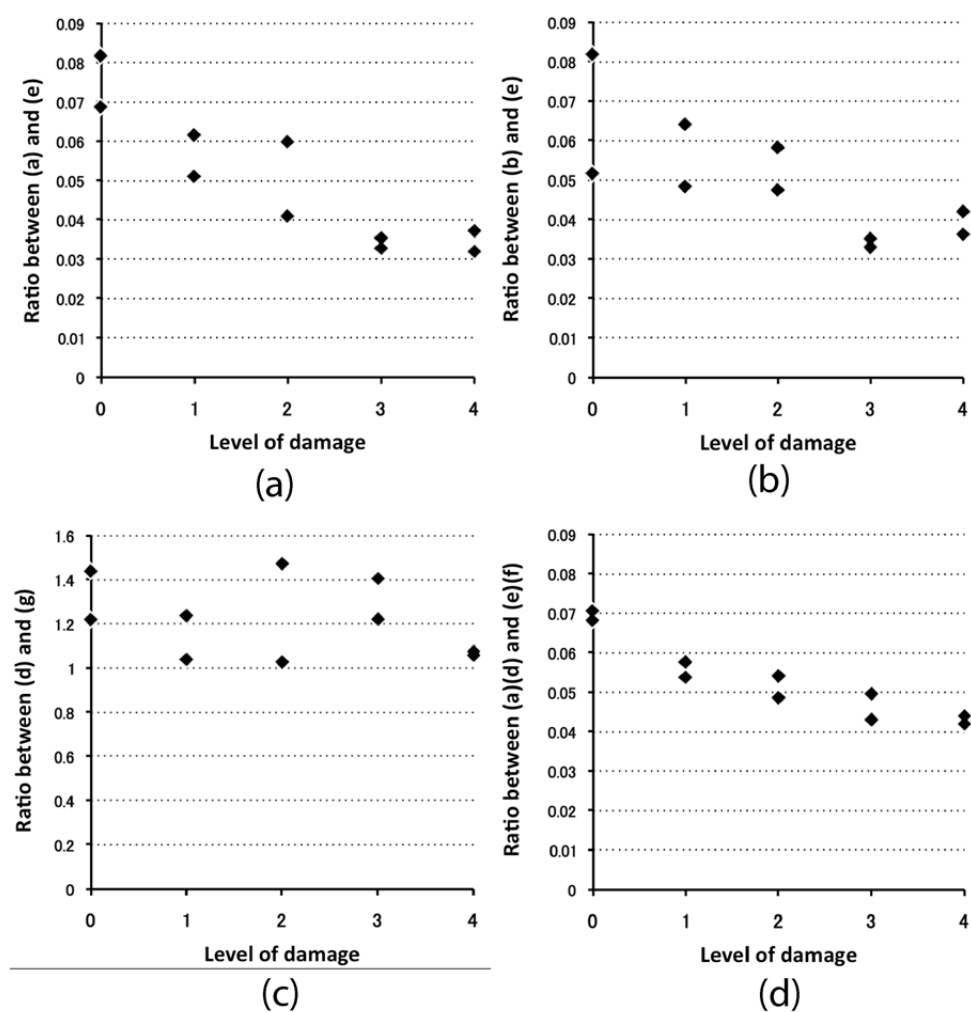
Figure 13a depicts the relationship between the ratios of the main column's dimension and short span of the core structure and level of damage. A declining tendency can be found, which indicates that the smaller the ratio becomes, the more damaged the structure is. Similarly, figure 13b shows a minor relationship between the ratio of the beam's height and the short span of the core structure and the levels of damage. While, figure 13c shows that there is no apparent relationship between the ratio of height-to-beam center and span of side structure and the levels of damage. This means that the scale of side structures has a low influence on the damage of the core structure.

The ratio of the vertical area of the main column and the horizontal area of the core structure could give better correspondence on the level of damage, as seen in figure 13d. A clear tendency is observed, showing that the smaller the ratio is, the more damage on structures is caused. Indeed the horizontal area of the core structure corresponds to the roof weight. The roof weight compresses that area and contributes to the instability in case of lateral earthquake forces. Therefore the ratio of the vertical section area (height of the main column) of the main column and horizontal area of core structure is a reliable indicator to estimate the earthquake resistance of Joglo structures. It can be used for self-checking the Joglo structures (e.g. by the owner). Values lower than 0.05 indicate a serious danger for the structural security and a necessity of reinforcement.

Figure 13. Comparison between structural proportion ratios and levels of damage, (a) Ration between (a) and (e) against level of damage, (b) Ratio between (b) and (e) against level of damage, (c) ratio between (d) and (g) against level of damage, (e) Ratio between (a/d) and (e/f) against level of damage.
